Manhole Inspection Summary

Manhole # S21G__015MH

Insp Date: **8/23/07 8:27 AM**

Location Address: **111 BRUCE ST**

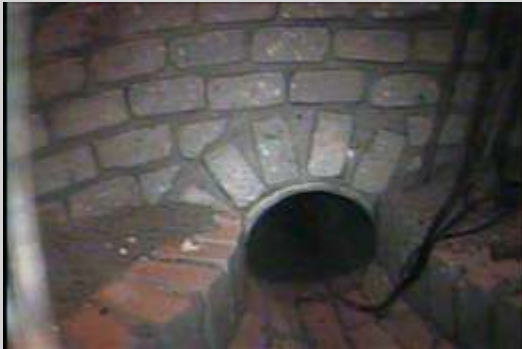
12 O'Clock Outflow

8 in. Circular Gravity Sewer
Pipe Out @ 12 O'Clock

Pipe Height: **8.4** (in.) Rod and Bar (Angled)
Pipe Material: **Clay** ☐ Pipe Lined
Invert Depth: **11.19** (ft.) Flow Characteristics: **None**
Deposits: ☒ None ☐ Mud ☐ Sludge ☐ Debris ☐ Grease
Silt Depth: (in.) Deposits Extent:
Infiltration: **None** Pipe Seal Cond: **Sound**

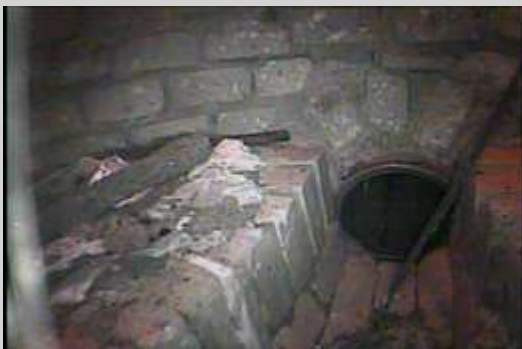
3 O'Clock Inflow

6 in. Circular Gravity Sewer
Pipe In @ 3 O'Clock

Pipe Height: **6** (in.) Rod and Bar (Angled)
Pipe Material: **Clay** ☐ Pipe Lined
Invert Depth: **10.84** (ft.) Flow Characteristics: **None**
Deposits: ☒ None ☐ Mud ☐ Sludge ☐ Debris ☐ Grease
Silt Depth: (in.) Deposits Extent:
Infiltration: **None** Pipe Seal Cond: **Sound**
